# VESSEL INSPECTION SUMMARY

Report #: **123812-KK-09**  
Inspect Date: 04/21/2010  
Page: 1 of 9  
IRISNDT #: 123812

Client: CNRL District: St. Albert Field: Cherhill  
Facility: Cherhill Comp Unit / Skid #: N/A LSD: 15-08-057-05W5M  
Jurisdiction #: A0419464 Equip Tag #: 04-16 Sep Serial #: 97168B  
CRN #: L-0404.2 Nat'l Bd #: N/A Year Built: 1998  
Manufacturer: Kanbuilt Industries Inc Equipment Description: Separator  
Status: In Service - Date Removed From Service: \_\_\_\_\_ Service: Sweet  
MAWP Shell: 720 Psi @ 100 °F Height/Length: 10 Ft. Code Stamp: ☒ Y ☐ N  
MAWP Tube: \_\_\_\_\_ @ \_\_\_\_\_ Size/Diameter.: 36 in. O.D. Insulated: ☐ Y ☒ N  
MDMT: -20 °F RT: RT-2 Volume: \_\_\_\_\_ PWHT: ☐ Y ☒ N  
Support Type: Skirt Manway: ☐ Y ☒ N  
C.A.: 0.0625 in. Coated: ☐ Y ☒ N Clad: ☐ Y ☒ N J.E.: \_\_\_\_\_ Remote Access: ☐ - \_\_\_\_\_

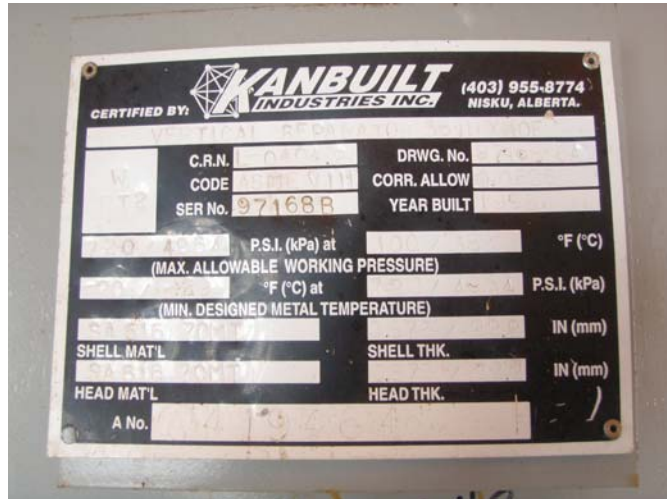
01-A0419464 Data Plate

Data plate is securely attached and easy to read.

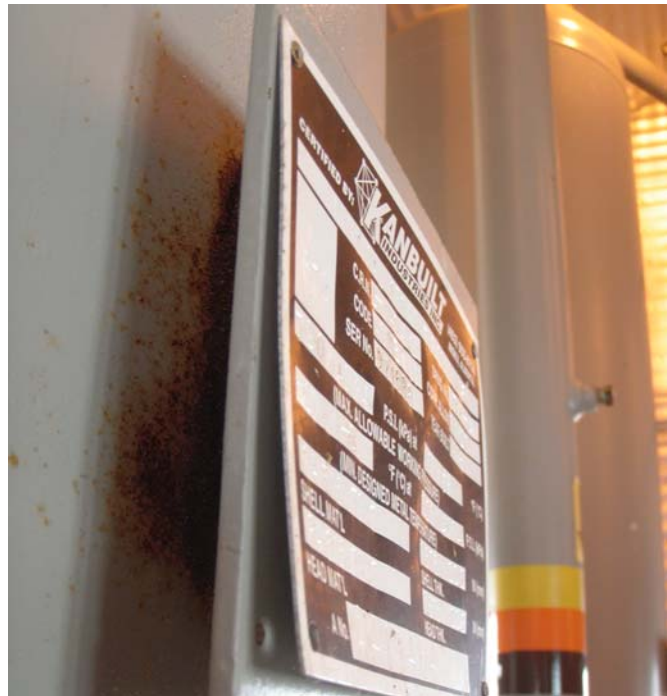
The data plate is missing one rivet and plate is loose.

04-A0419464 Loose Data Plate

Insert a rivet where there is one missing to secure the data plate firmly in place.

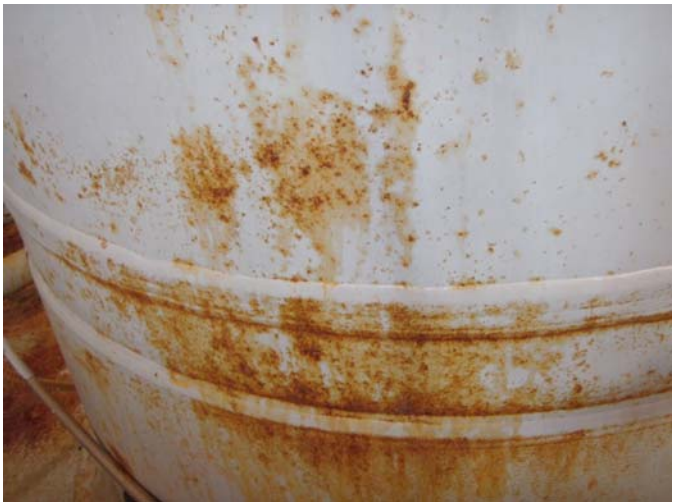
There are isolated rough surfaces, staining, thick/ rough paint, and chipping or flaking paint noted throughout.

The vessel is painted and is in fair visual condition with chipping and flaking paint noted throughout.

**05-A0419464 Vessel Surface Corrosion**

Clean and repaint this vessel in the areas where paint is flaking.

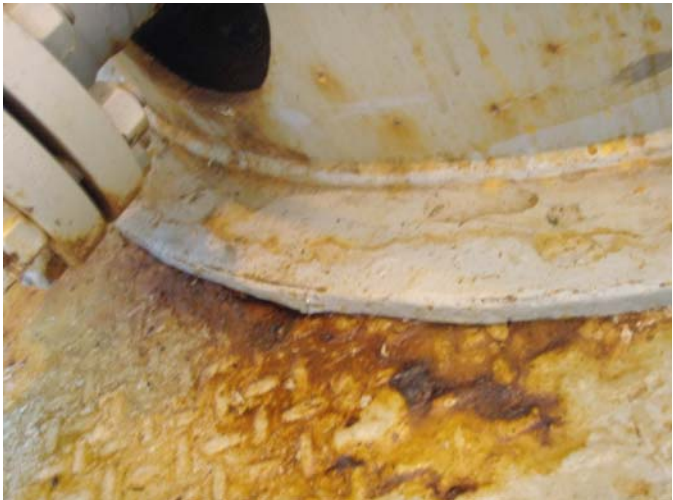
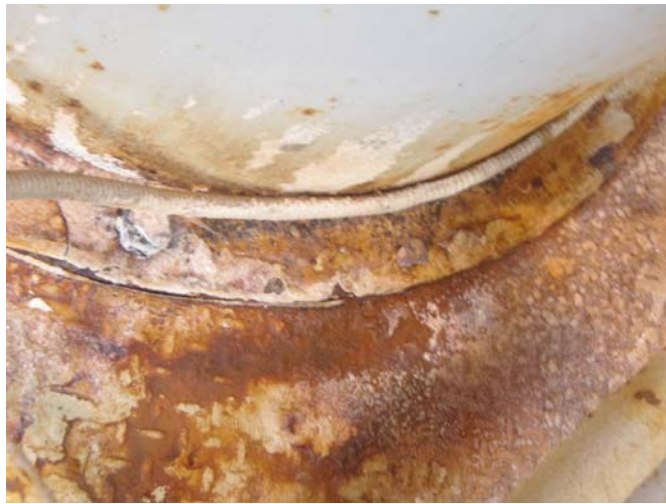
There is corrosion and flaking paint noted at the floor where the vessel base is bolted.

**06-A0419464 Base Corrosion**

**07-A0419464 Base Corrosion 2**

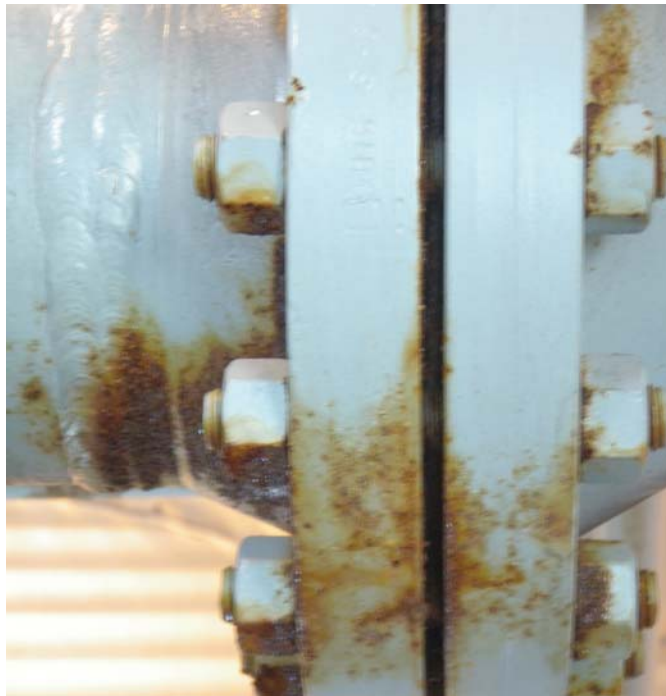
The inlet and outlet piping have surface corrosion @ the flange faces and on the piping.

**08-A0419464 Inlet Flange Surface Corrosion**

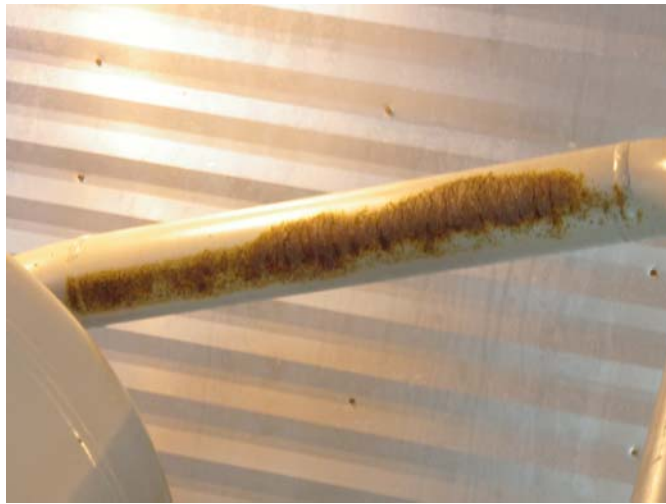
**09-A0419464 Outlet Piping Surface Corrosion**

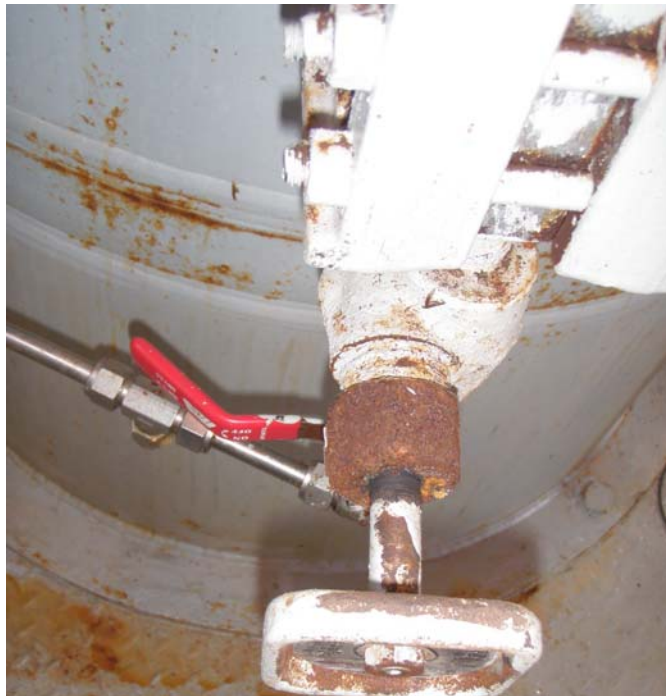
The bottom liquid level valve packing ring has surface corrosion.

**10-A0419464 Liquid Level Valve Packing Corrosion**
