Report #: 137865-WF-45 Inspect Date: 05/13/2009 Page: 1 of 6 IRISNDT #: 137865

2.2 Nat'l Bd #:			Year Built:	20	003			
Manufacturer: Enerflex Equipment Description: Inlet Separator									
Status: In - Shutdown					Sweet				
MAWP Shell: 740 Psi			. 0.5		e Stamp:				
MAWP Tube:	@ Size/Dia			Ir	nsulated:				
	RT: RT-2 V	/olume:		_	PWHT:				
Support Type: Saddle C.A.: 0.0625 in.	Coated: YN Clad: [L NUYD	F · Rem		Manway: □ -				
Component	Material	Nominal Thk	Diameter		be Side	Shell Side

VESSEL INSPECTION SUMMARY

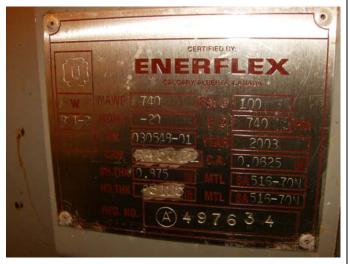
Figure 1_Nameplate_13May09

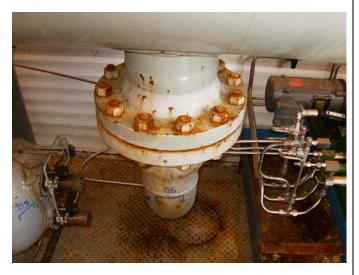
Figure 3_Paint Deteriorating_13May09

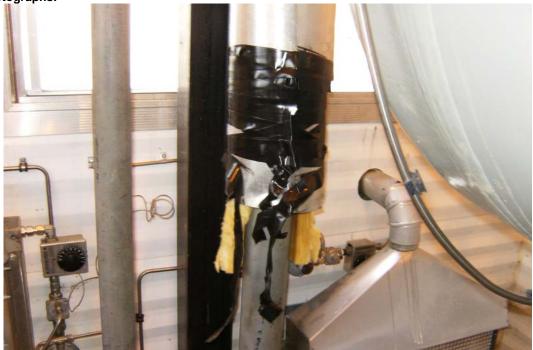
Figure 5_Insulation Damage to Drain Piping_13May09
