**Canadian Natural Resources Limited
GENERAL PRESSURE VESSEL INFORMATION**

Job # 10.111452

| Facility: Spring Lake Gas Gathering | | Location (LSD): 06-13-76-12W6M | | | | |
| Vessel Name Equipment Number: 3 Phase Separator | | | | | | |

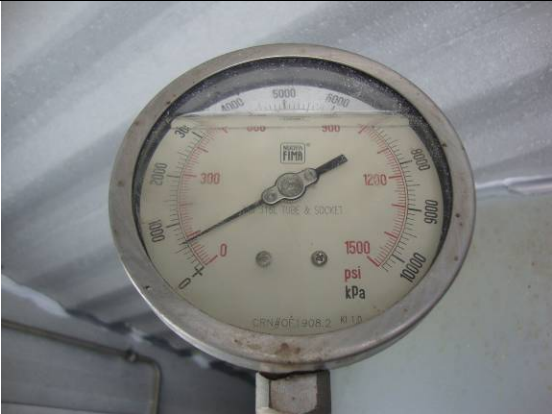
Pressure gauge

| External Inspection Items | G | F | P | N/A | Comments |
|---|---|---|---|---|--|
| Gauges Ensure gauges are visible, working, no leakage, and suitable for range of MAWP/ Temp. | X | | | | Clear and clean – no leakage. Within operational range for service – pressure gauge 0 – 1500 PSI/temperature gauge 0 – 250 Deg F. |

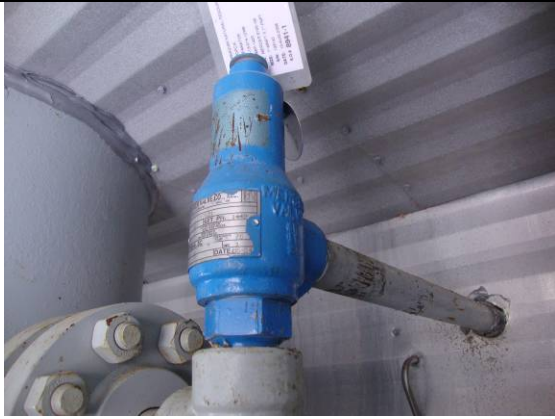
| External Inspection Items | G | F | P | N/A | Comments |
|---|---|---|---|---|--|
| PSV Ensure PSV is set at pressure at or below that of vessel. | X | | | | Location: On upper shell- Set below MAWP of vessel. No block valve between vessel and PSV. Discharge piping is same size as valve out let. Seal in place. |

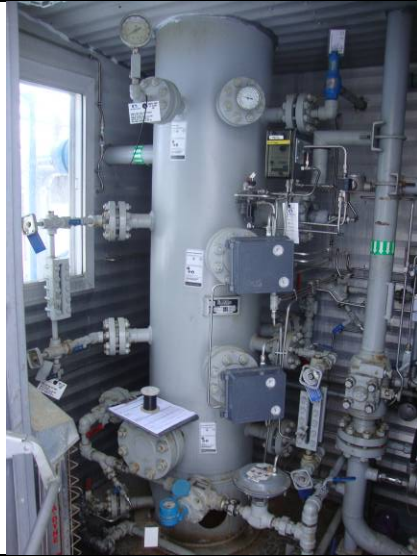
Vessel overview

| External Inspection Items | G | F | P | N/A | Comments |
|---|---|---|---|---|--|
| Recommendations or corrective actions : Vessel is Fit for Service or describe corrective actions required) (MIC to review corrective actions with Operations, discuss with Chief Inspector where necessary, and get remedial action implemented) Recommendations: No recommendations. Summary: Vessel is in overall good condition, visual external inspection and ultrasonic corrosion survey performed – no metal thickness detected below nominal minus corrosion allowance. Long term corrosion rate based on greatest thickness loss (head) 0.170mm per year. Retirement Date to “T”min is year 2043. Vessel is fit for service. | | | | | |
