**Canadian Natural Resources Ltd.
GENERAL PRESSURE VESSEL INFORMATION**

Job# 105.00390

District: Fort St John, BC	Skid No.
Facility: Ladyfern Compressor	Location (LSD): b-17-I/94-H-01
Vessel Name Equipment Number: Glycol Contactor	
Orientation: Vertical	
Status: In Service	Regulatory Inspection

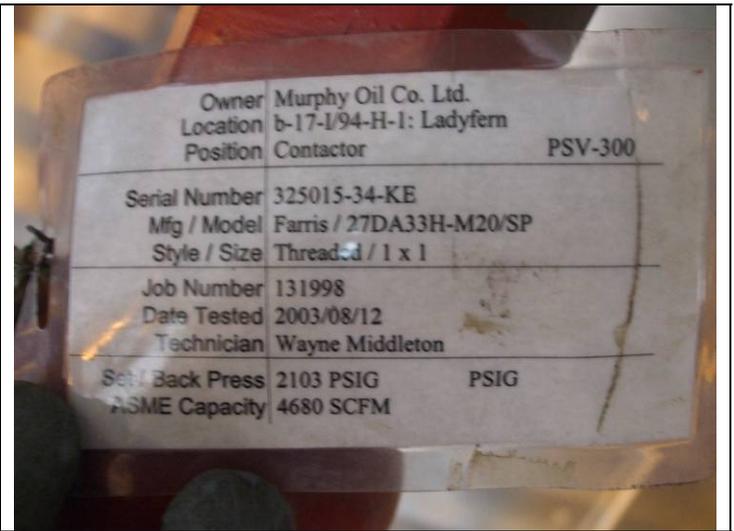
Valving Ensure no leaks are visible. Valves are properly supported and chained if necessary.	X				Well supported – no leaks.
PSV Ensure PSV is set at pressure at or below that of vessel.			X		Located on the gas inlet piping - set above the Contactors MAWP. PSV is over due for servicing, last serviced in 2003. Discharge piping is the same size as the inlet to PSV. No block valve present. Seal is intact. PSV vents to Flare.
NDE methods Was UT/ MPI done on vessel (MI coordinator to review results)	X				Ultrasonic thickness survey carried out-no metal thickness detected below nominal.
Other					
Recommendations or corrective actions : Vessel is Fit for Service or describe corrective actions required) (MIC to review corrective actions with Operations, discuss with Chief Inspector where necessary, and get remedial action implemented) Recommendations: 1. The PSV for this contactor is set above its MAWP – it needs to be lowered to @ or below the vessels MAWP & it is over due for servicing. Summary: This vessel is in good over all condition, visual external and ultrasonic thickness survey carried out-no metal thickness detected below nominal. Vessel is fit for service.

PSV service tag – last service was in 2003
