GENERAL INSPECTION FORM

District: North	Skid No.
Facility: Ladyfern Compressor Station	Location (LSD): 04-30-94-12 W6M
Vessel Name & Equipment Number: Sweetening Tower	
Orientation: Vertical	
Status: In Service	Regulatory Inspection

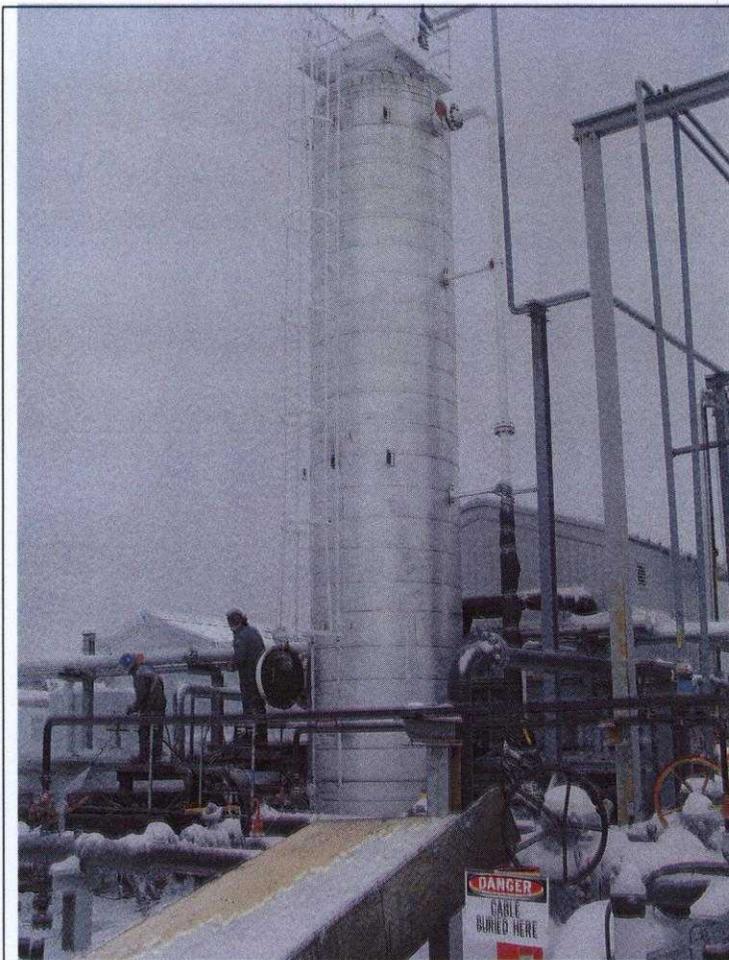
Over view of vessel.

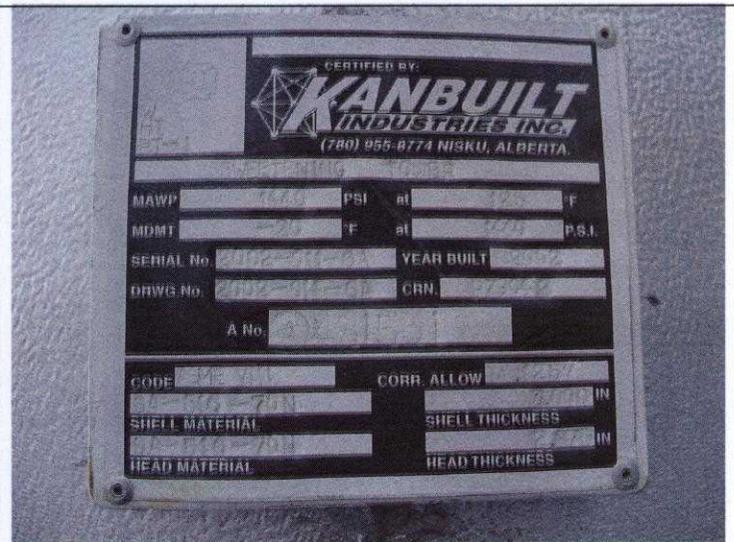
Data plate

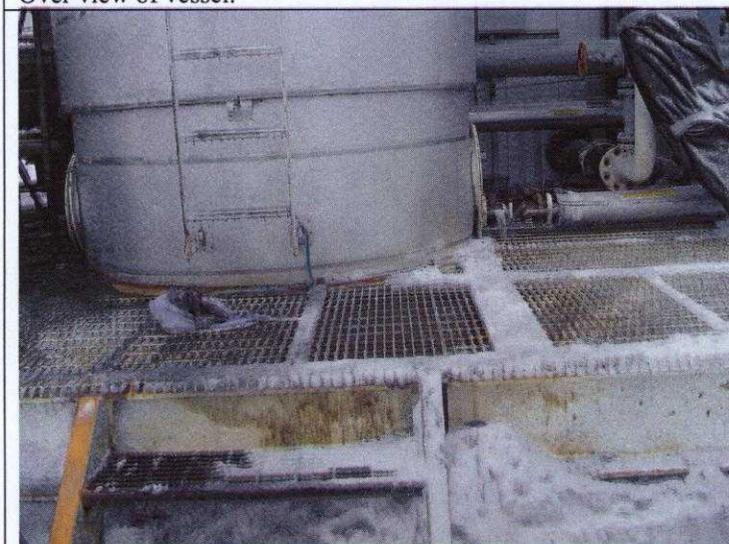
Vessel is mounted on skid platform – ground cable attached

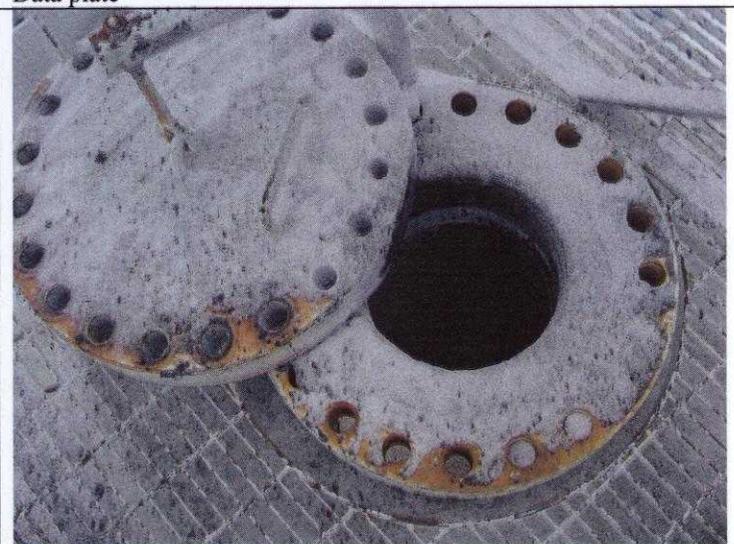
Top head – loading nozzle.

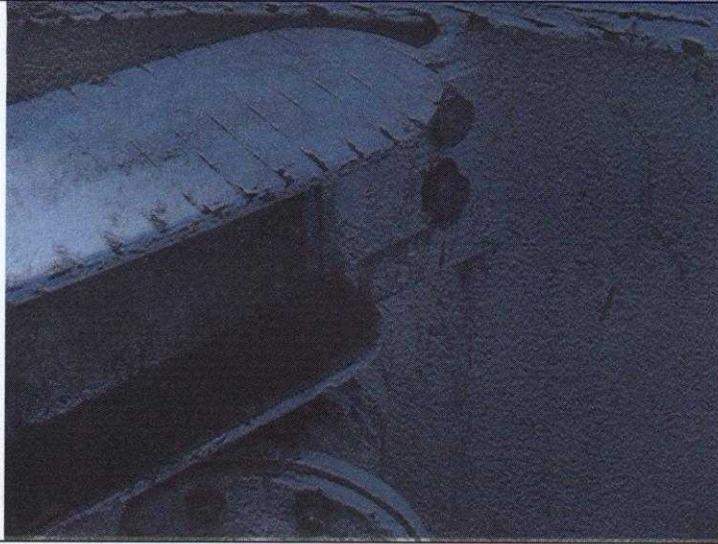
1 support member

Repairs Required. If yes, ensure procedure and copy of AB 40 is on file, and one sent to local ABSA, and Chief Inspector	X				“I” beams to be straightened and re welded. Grating to be straightened and put back into vessel.
NDE Was any NDE done. (MI coordinator to review results)				X	No NDE inspections at this time.
Recommendations or corrective actions : Vessel is Fit for Service or describe corrective actions required) (MIC to review corrective actions with Operations, discuss with Chief Inspector where necessary, and get remedial action implemented) Other Observations:

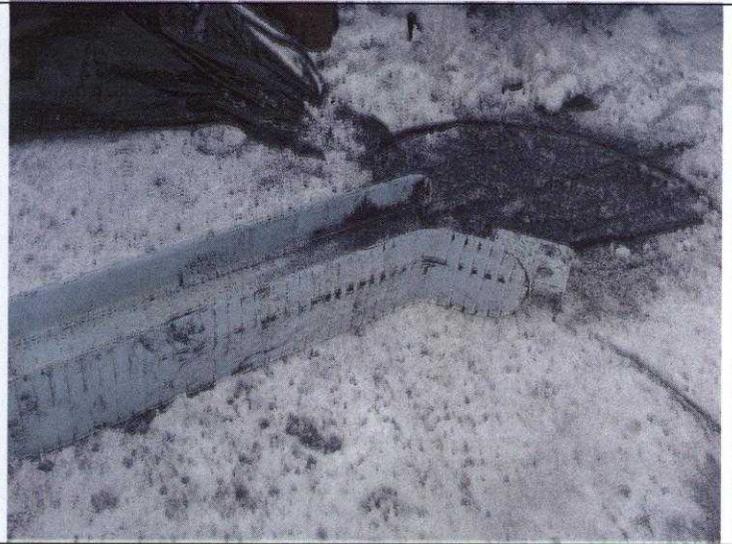
Broken support member

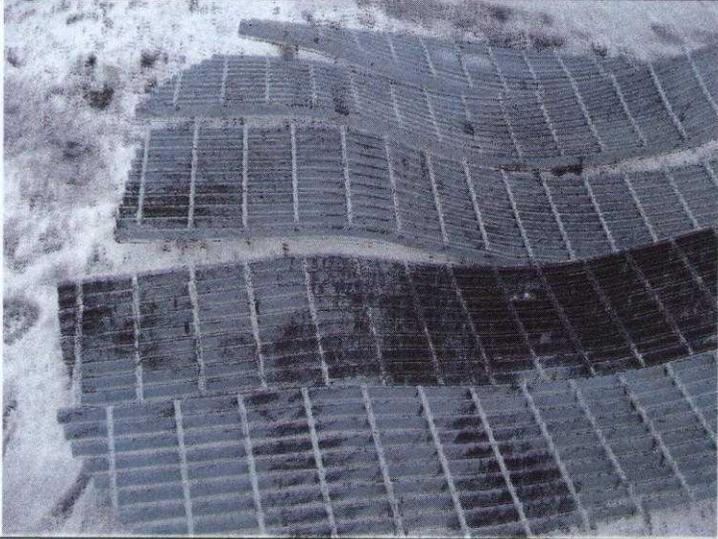
Grating – bent and distorted

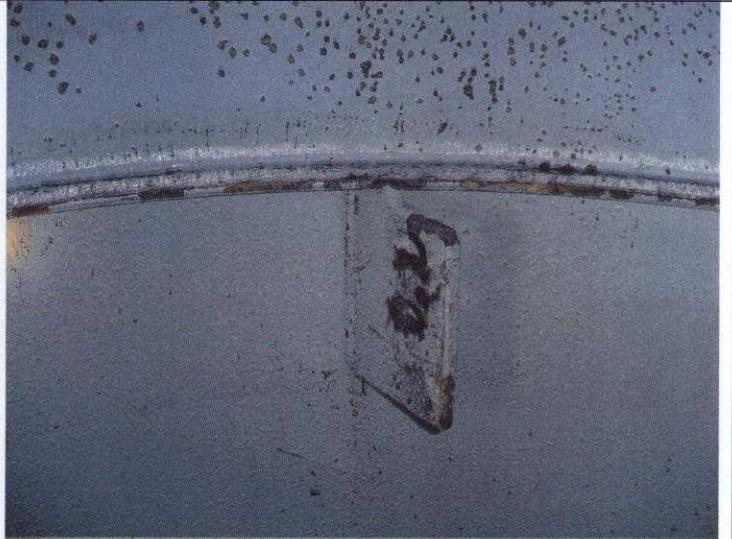
Support attachment area

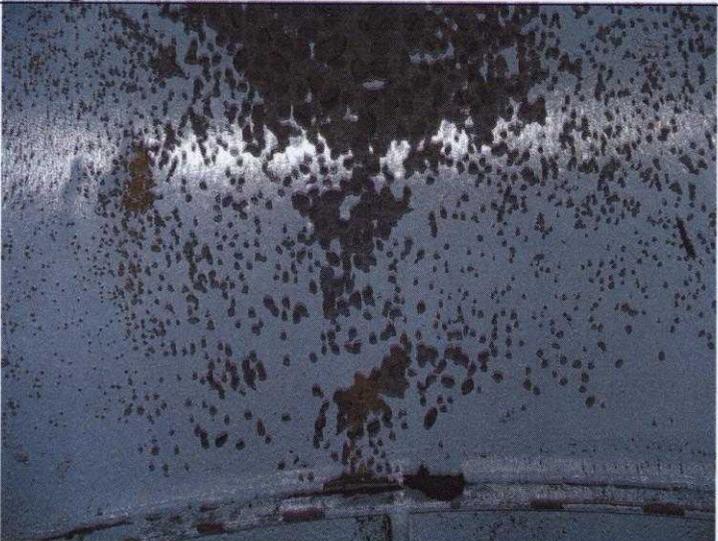
Internal Inspection Items	G	F	P	N/A	Comments
Coating Assess coating. Describe area coated, general condition of coating.			X		Coating has failed to full area of bottom shell course and to 20% of bottom head area.
Anodes. How many, type, condition. % consumed. Are they being replaced?				X	No anodes
Internal Piping Is there any? If so, carbon or stainless steel. Describe condition, dents, corrosion, erosion, etc. Ensure supports are secure and any bolts are suitable for future use.				X	No internal piping.
Trays How many? Type of material. Are valves in place. Check for erosion/ corrosion; wear on tray valve legs. Cleanliness?			X		Bottom grating supports – 2 broken “I” beams, and all grating bent, buckled and distorted.
Baffles, deflector plates, etc. If present, describe condition. Look closely at welds attached to vessel wall.				X	No baffles, deflectors etc...
Top Head Note all corrosion, erosion or mechanical damage. (If vessel is horizontal identify direction of this head)	X				Good condition, no failed coating, no previous pitting.

Lower shell – failed coating

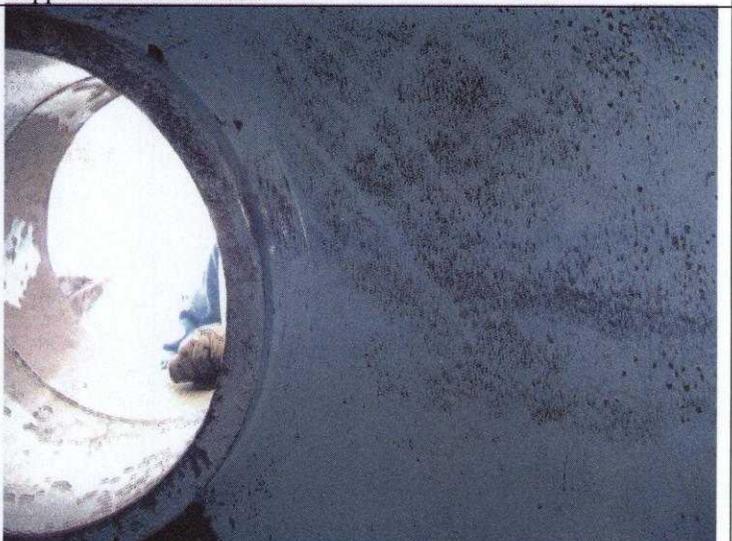
Man way access and shell

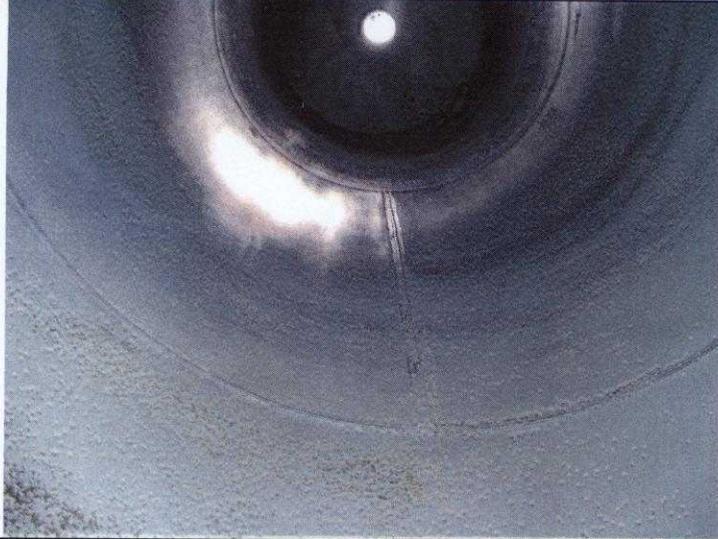
Upper shell and top head

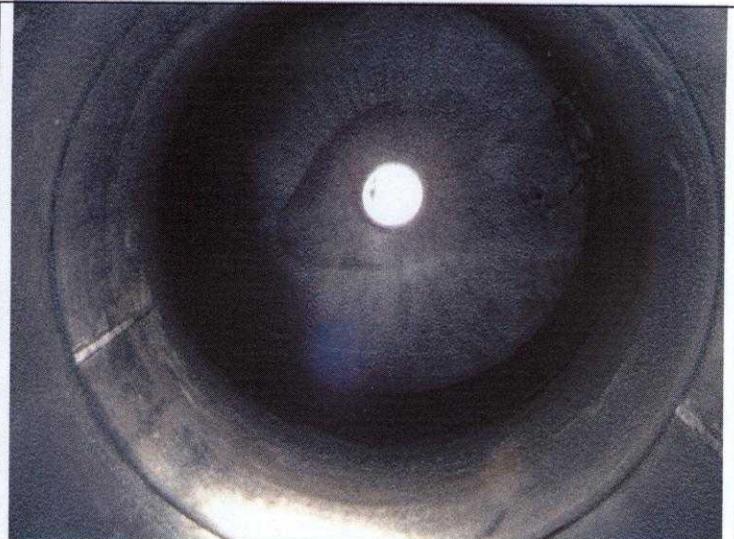
Top head

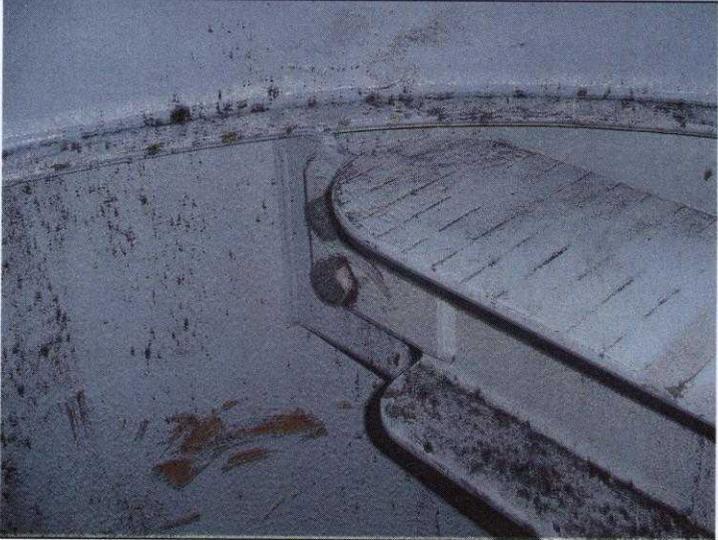
1 remaining support
