GENERAL INSPECTION FORM						
District: Hamburg			Skid No. :			
Facility: Mearon Gas Gathering			Location (LSD) Surface: 04 -30- 94 - 12 - W6M			
Vessel Name & Equipment Number: Sweetening Tower						
Orientation: Horizontal <input type="checkbox"/> or Vertical <input checked="" type="checkbox"/>			Location (LSD) Downhole:			
Status: In Service <input checked="" type="checkbox"/> or Out of Service (blinded / fully isolated) <input type="checkbox"/>			Commissioning Inspection <input type="checkbox"/> or Regulatory Inspection <input checked="" type="checkbox"/>			
PRESSURE VESSEL NAMEPLATE DATA						
"A" or "G" or "S" (Sask.) or BC Registration Number. A 0481551			CRN Number P 7904.2			
Vessel serial number: 2002-011-6A			Size (diameter x length- estimate if necessary): 60 in x 288 in			
Shell thickness: 76.2 mm			Shell material: SA 516 70N			
Head thickness: 73.0 mm			Head material: SA 516 70N			
Tube wall thickness:			Tube material:

Summary of damage and recommendations for repair.

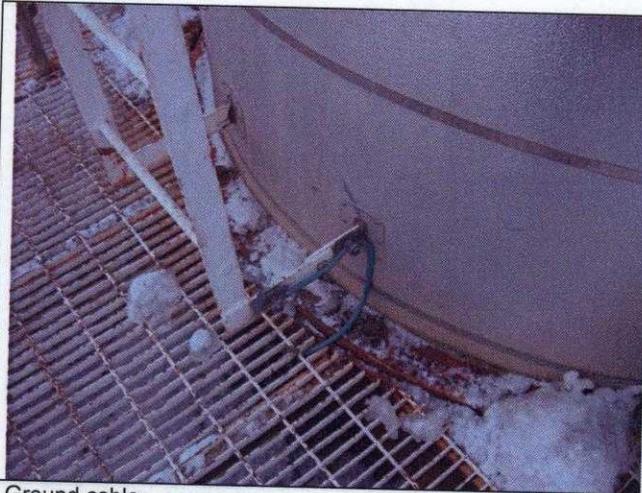
Ground cable

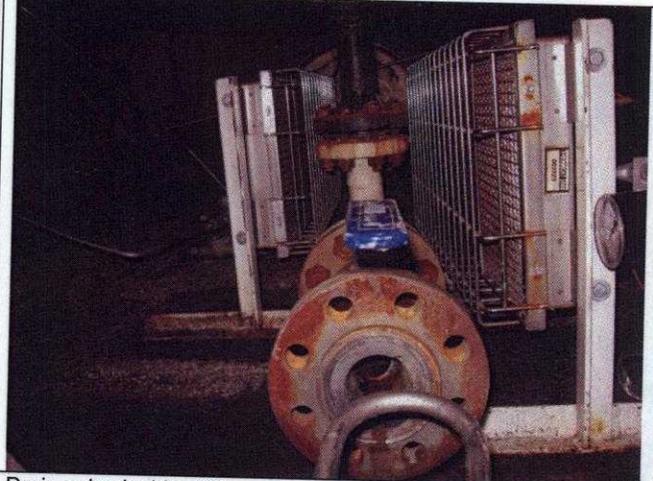
Drain valve inside skirt

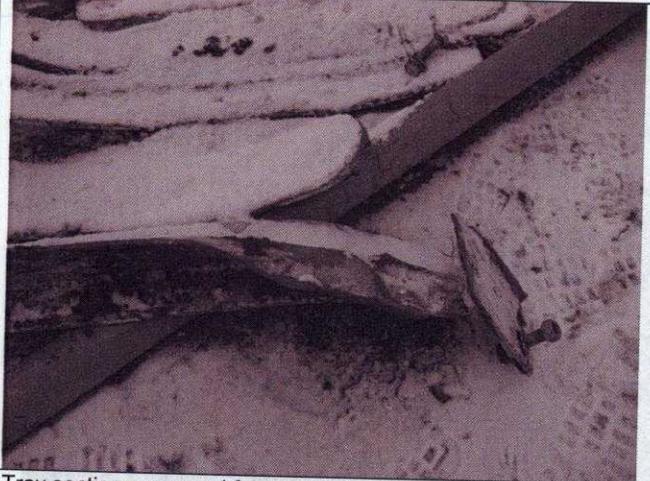
Trays How many? Type of material. Are valves in place. Check for erosion/ corrosion; wear on tray valve legs. Cleanliness?			X		The full tray section on the lower head that supports the catalyst bed was completely broken from the anchors and damaged beyond repair.
Baffles, deflector plates, etc. If present, describe condition. Look closely at welds attached to vessel wall.	X				Gas inlet diffuser in the upper shell is intact and in place.
Top Head Note all corrosion, erosion or mechanical damage. (If vessel is horizontal identify direction of this head)	X				This area is coated with epoxy and is still in good condition – no exposed metal.
Bottom Head Note all corrosion, erosion or mechanical damage. (If vessel is horizontal identify direction of this head)	X				Coated with epoxy – there are a large number of sections that are missing coating due to impact damage from tray grating when it was dislodged from anchors. There is no corrosion or pitting to these exposed areas.

Tray sections removed from vessel.

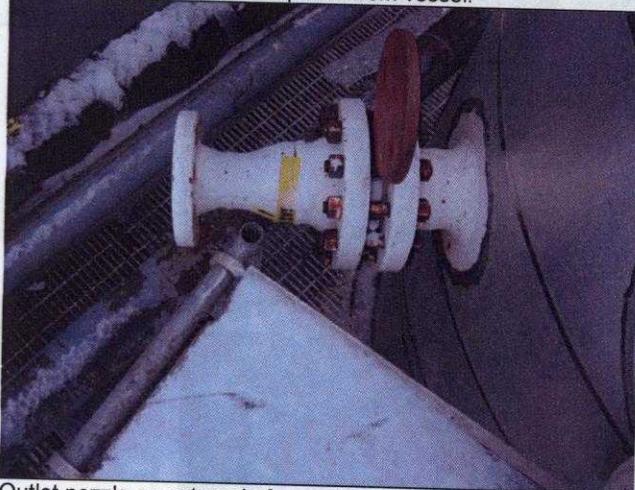
Outlet nozzle on external of vessel.

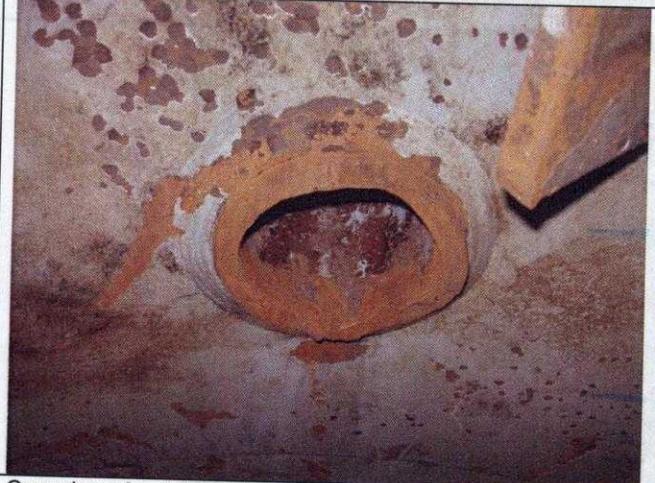
Over view of outlet nozzle back weld. There is still metal above back weld. This could have a shorter protrusion welded to it. The original protrusion was excessively long - 16 inches.

1. Build new tray / grating sections for installation into tower.
2. Manufacture new stub (6 inches long – 6 inches diameter schedule 160 with a 150 lb flange for the new gas pipe extension to attach to) and weld onto existing back welded nozzle section. There should be enough to weld to with weld prep on one side of the new stub. The 6 inch nozzle should not require a protrusion for reinforcement as the shell is 76.2 mm thick and the nozzle is 22.2 mm thick. A temper bead weld procedure could be used for this. Alternatively the area could be stress relieved.

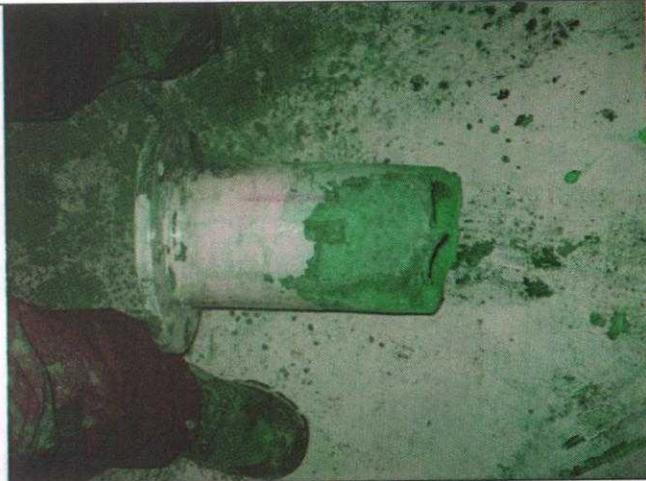
Outlet nozzle protrusion broken from shell

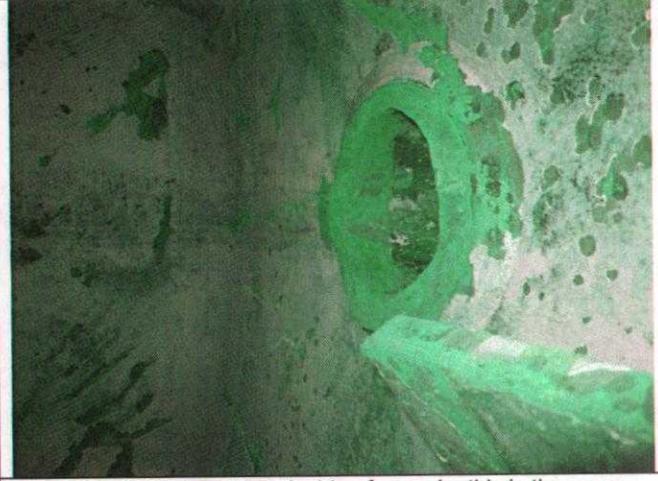
Outlet nozzle back weld on inside of vessel – this is the area where the protrusion broke off.

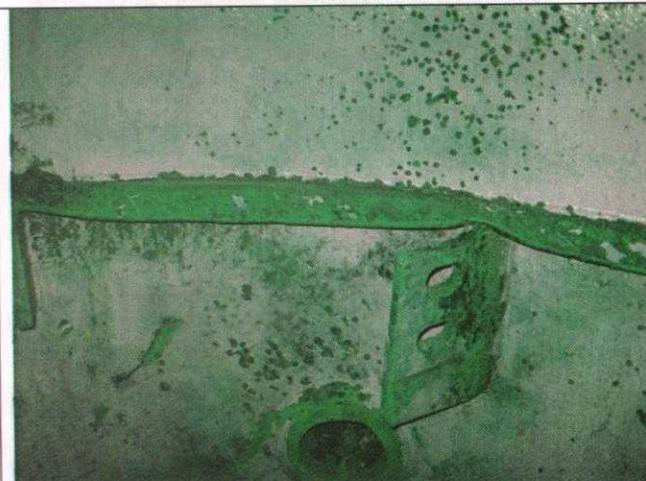
Distorted ring

3. Install new tray support ring – full circumference. The ring is still welded to the shell and the weld could be left bonded to the shell and the new ring welded to it. As the weld would not come in contact with the shell – stress relieving could be avoided.

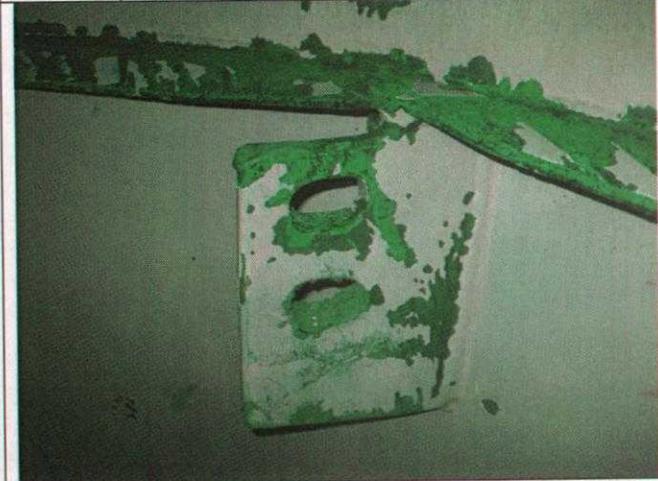
Distorted ring

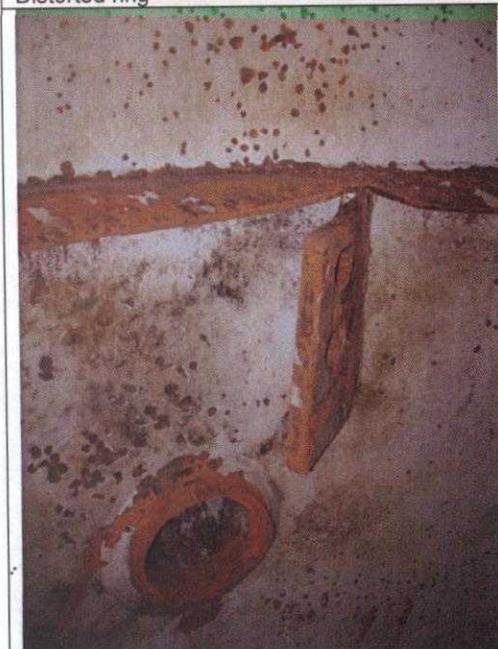
Distorted support ring and nozzle attachment

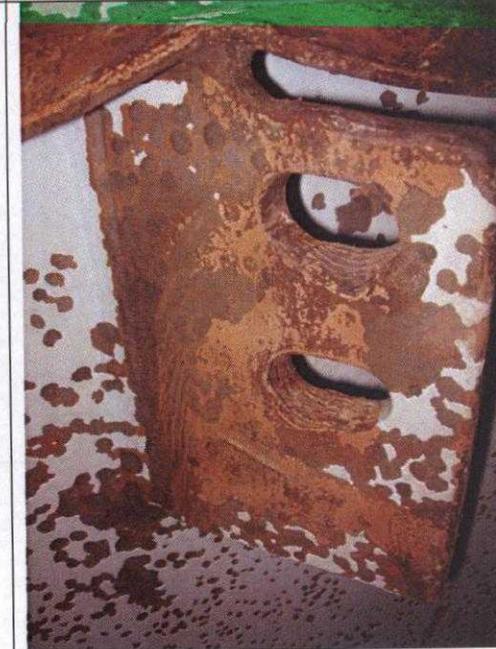
Grating supports – elongated holes from wear

4. Gas pipe extension: This would need to be manufactured and bolted to the nozzle extension – 6 inch schedule 40 with a 150 lb flange.
5. The support brackets can have the holes / slots welded up where they are worn and ground to original size – this can be done in situ.

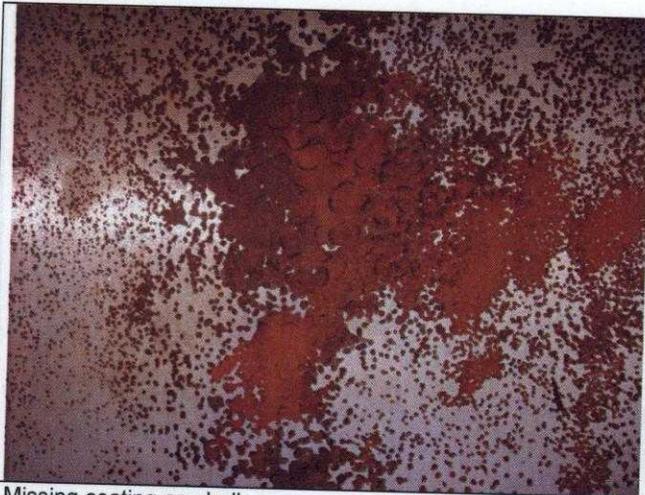
Missing coating on shell

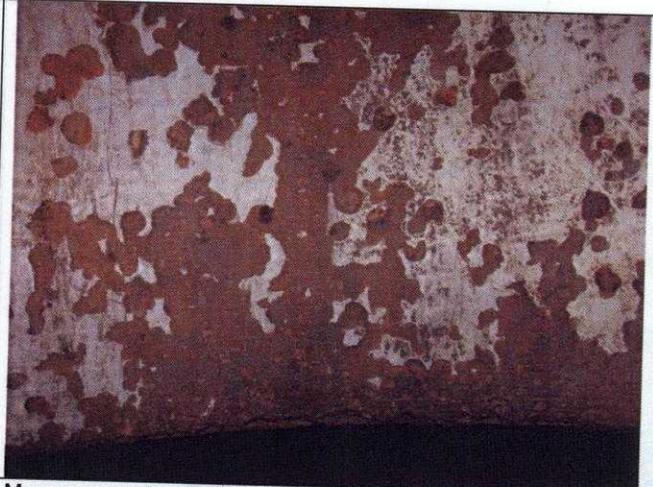
Man way nozzle – isolated pitting to .100 inches deep

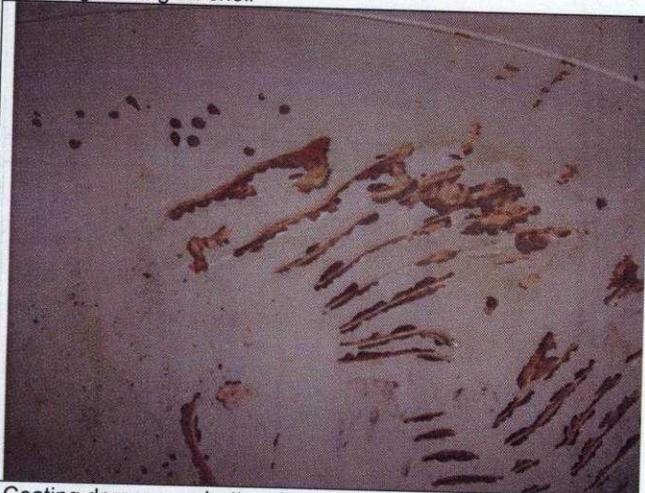
Coating damage on bottom head

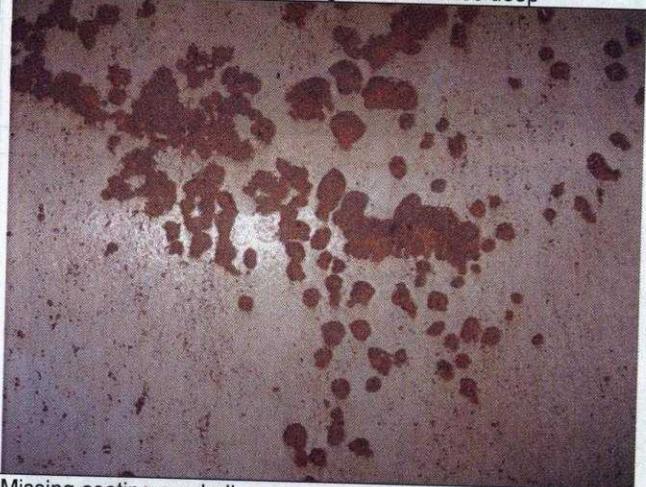
Missing coating on shell
