**Canadian Natural Resources Limited
GENERAL PRESSURE VESSEL INFORMATION**

Job # 10.110056

District: Grande Prairie AB.	Skid No.
Facility: Knopcik Gas Gathering	Location (LSD): 07-07-73-10W6M
Vessel Name Equipment Number: Line Heater	
Orientation: Horizontal	
Status: In Service	Regulatory Inspection

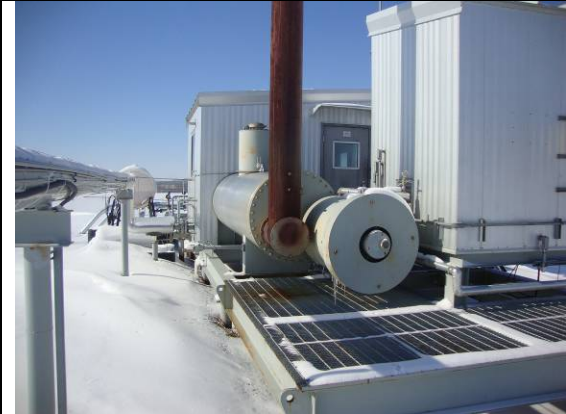
Vessel front end view
