GENERAL PRESSURE INFORMATION

District: _____ **Skid No. 6549**
Facility: Hamburg GAS GATHERING **Location (LSD) 04-30-94-12W6**
Vessel Name & Equipment Number: Sweetening Tower

VISUAL EXTERNAL REPORT

A#:	481551
Name:	Sweetening Tower
LOC:	Hamburg Field
LSD:	04-30-94-12-W6M
Picture 1:	Nameplate
Picture 2:	Vessel Overview

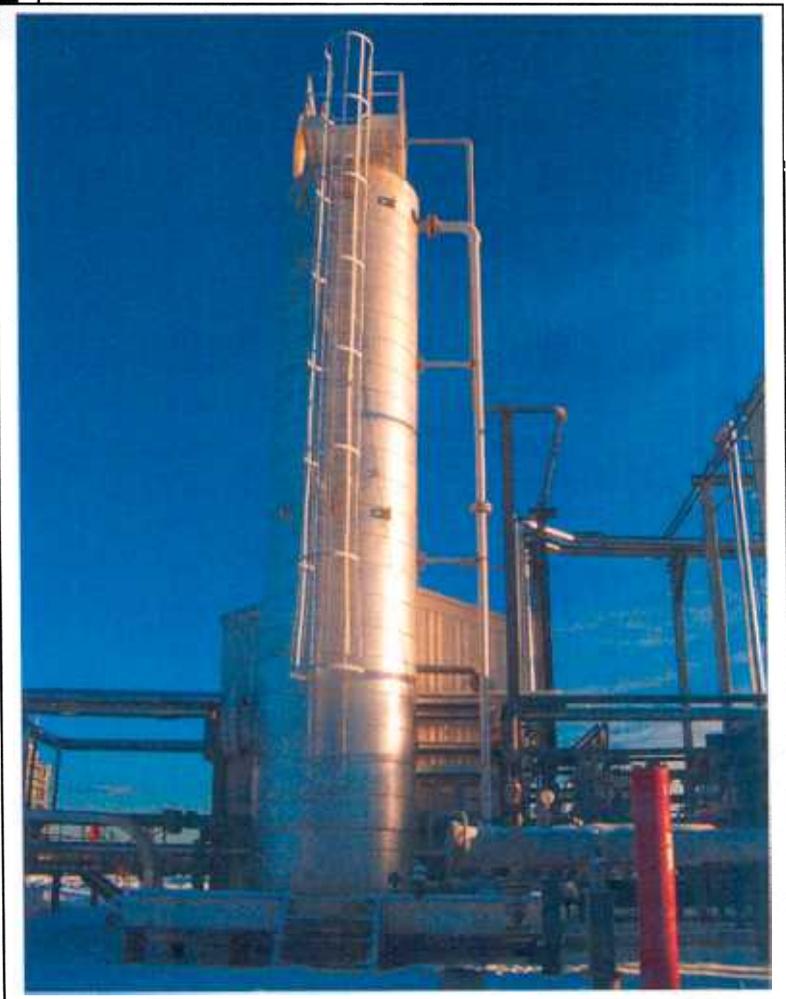
External Inspection Items A481551: Sweetening Tower	Good / Fair Poor / N/A	Comments
Insulation Verify sealed around manways, nozzles, no damage present, and there is no egress of moisture.	Good	Insulation sealed around manways, no visible damage, no visible egress of moisture.
External Condition Assess paint condition, areas peeling, record any corrosion, damage, etc (record location size and depth of corrosion or damage)	Good	Paint in good condition, no areas of corrosion or damage. No visible signs of leakage.
Leakage Record any leakage at flanges threaded joints, weep holes on repads, etc.	Good	No visible signs of leakage.
Skirt/ Saddle Assess condition of paint, fire protection, concrete. Look for corrosion, buckling, dents, etc. Look at vessel surface area near supports. Verify no signs of leakage at attachment to vessel and attachment welds are acceptable. Ground wire attached?	Good	No dings or dents, vessel bolted to skid, skid ground wire attached.
