## Ultrasonic Inspection Report

Report #:	1245	15-BV-08	IRISN	NDT Job #:	-	124515	Date:	2008	Page	<b>1</b> of	1	
Client:	: CNRL		PO/Job #:				Contact:	MIKE S	STREET			
Job location:								Tel:	(403) 5	02 5920		
LSD 09-16-020-11W4M Fax:												
Procedure(s):		ICKNESS										
Code(s): ASME SECTION V111

Scope: Carry out UT Examination of the A0137252 Glycol Contactor. Check for corrosion of the Shell, and Head to verify the integrity for service and identify any areas of concern. Examination revealed the following:												
and anti-graph for the and receiving any areas or convert a Daminiation revealed the ronowing.												
Devoltes ITT constitution was considered and all readings to long at 10th and a 10th and												
Results: UT examination was carried out; all readings taken were 10"band scans with three readings per band/location.  Minimun, Maximum and Average readings were taken in each location and recorded.												
All readings were found to be above nominal on the Shell and bottom Head.  No areas of concern were found at time of inspection.												
110 areas of concern were found at time of inspection.												
Recommendations: Continue to carry

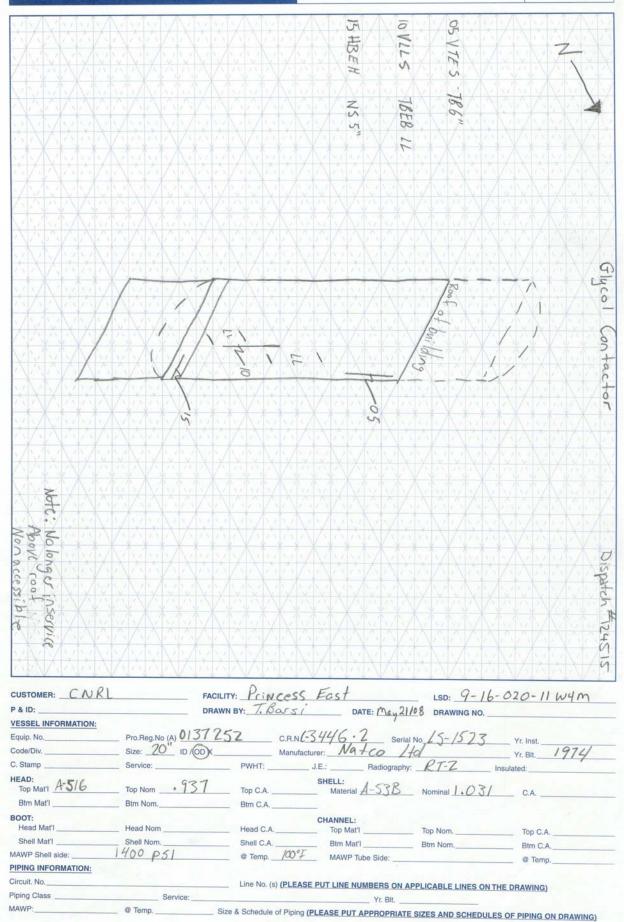
carry out UT Corrosion survey at the required frequency.												
See Attached Drawing, pictures and UTM file for Locations and thicknesses recorded.												
Final Comment:												
A0137252 Glycol contactor is fit for continued service.  Assistant: TRACY BARSI Technician: BLAIR VERGE												
GGSB SNT UT Level: I III No.#:							☐ CGSB ☐ SNT UT Level: ☐ II ☐ III No.#: 5586					
Unit: 393 Km: Travel Time:							Signature:					
Start: Stop: Work hrs:												
☐ OT Meal ☐ Subsistence required Total hrs: Client Name:												
Consumables:							Signature:					
							Dignature.
