ConocoPhillips Canada

GENERAL PRESSURE VESSEL INFORMATION

District: Grande Prairie, AB		Skid No.	
Facility: Ladyfern Gas Gathering		Location (LSD): 04 - 30 - 94 - 12 - W6M	
Vessel Name & Equipment Number: Sweetening Tower			
Orientation: Vertical			
Status: Operating		Regulatory Inspection	
PRESSURE VESSEL NAMEPLATE DATA			
"A" or "G" or "S" (Sask.) or BC Registration Number. A 481551		CRN Number P 7904.2	
Vessel serial number: 2002-011-6A		Size (diameter x length- estimate if necessary): 60 in. x 24 ft.	
Shell thickness: 76.2 mm		Shell material: SA 516 70 N	
Head thickness: 73.0 mm		Head material: SA 516 70 N	
Tube wall thickness:		Tube material:	
Tube diameter:		Tube length:	
Channel thickness:		Channel material:	
Design pressure	Shell: 1440 Psi	Operating pressure	Shell:
	Tubes:		Tubes:
Design Temp.	Shell: 100 deg F	Operating temperature	Shell:
	Tubes:		Tubes:
X-ray: RT 1		Heat treatment: HT	
Code parameters: ASME VIII / Div 1		Joint efficiency (if on nameplate):

Sweetening Tower – A 481551

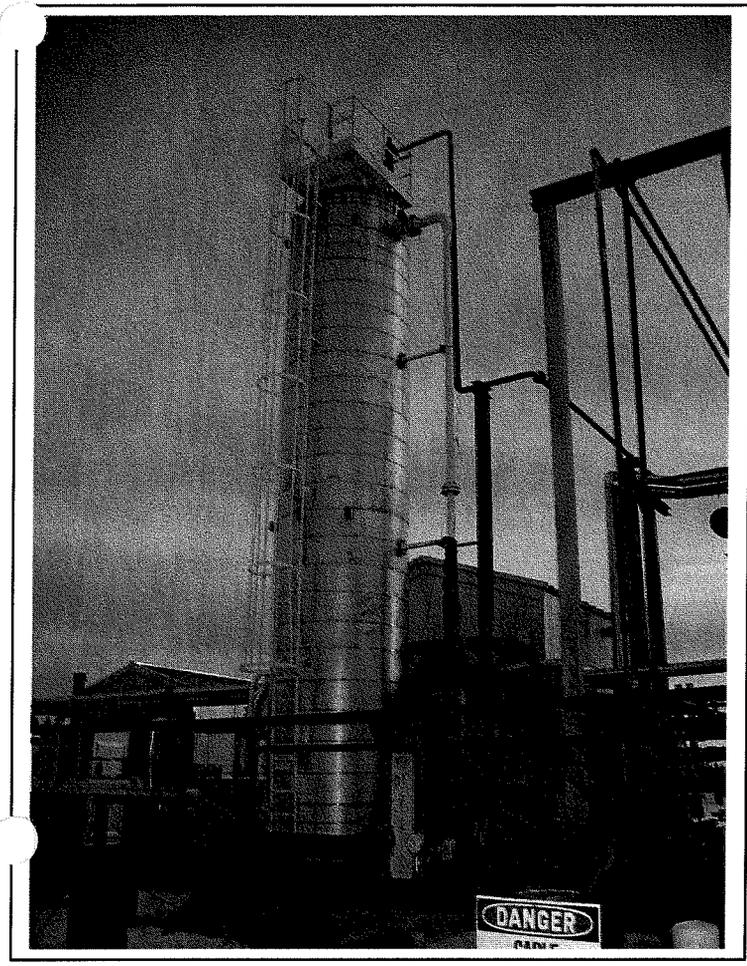
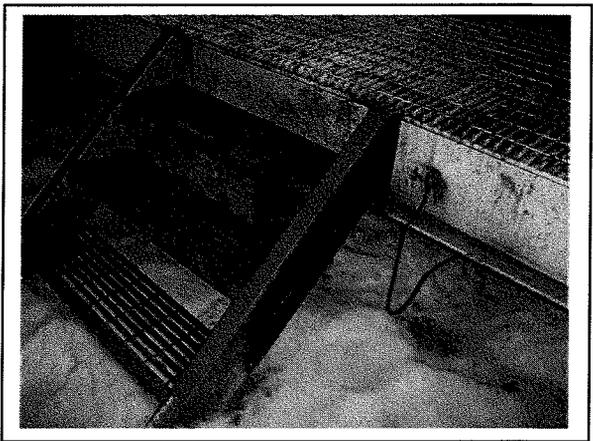
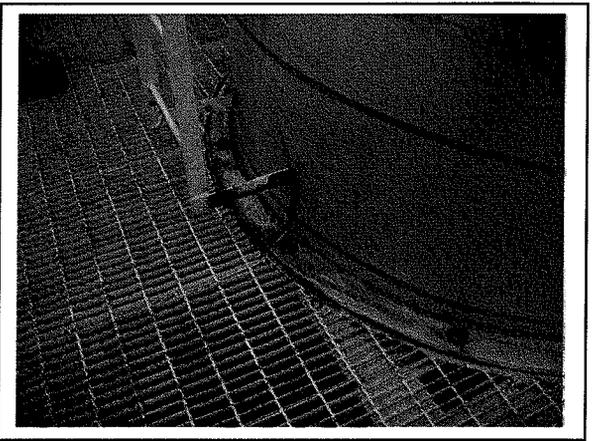
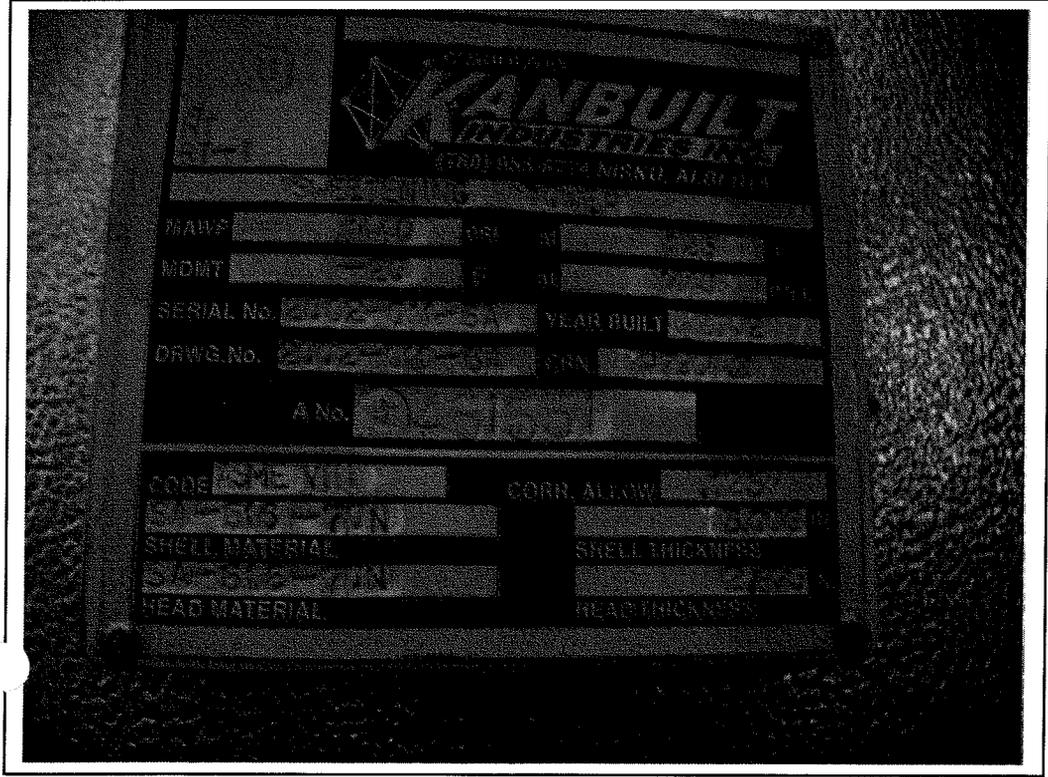
External Inspection Items A 406900	G	F	P	N/A	Comments
Insulation Verify sealed around manways, nozzles, no damage present, and there is no ingress of moisture.	X				100% insulated – No open or torn sections.
External Condition Assess paint condition, areas peeling, record any corrosion, damage, etc (record location, size and depth of corrosion or damage)				X	Vessel is insulated.
Leakage Record any leakage at flanges, threaded joints, weep holes on repads, etc.	X				No leaking detected.
Saddle Assess condition of paint, fire protection, concrete. Look for corrosion, buckling, dents, etc. Look at vessel surface area near supports. Verify no signs of leakage at attachment to vessel and attachment welds are acceptable. Ground wire attached?	X				Good condition, no distortion, firmly bolted to platform on pilings. Attachment welds are in good condition. Ground cable attached to pilings.
Anchor Bolts Hammer tap to ensure secure. Look for cracking in treads or signs of deformation.	X				Firmly bolted to platform.

Concrete foundation Check for cracks, spalling, etc.				X	Platform deck sits on pilings.
Ladder / Platform Describe general condition, ensure support is secure to vessel, describe any hazards.				X	Good condition, no loose or missing sections – platform attached to vessel.
Nozzle Assess paint, look for leakage, and ensure stud threads are fully engaged. Record any damage, deflection, etc. Are nozzles gusseted?	X				No deflection or leaking. Nozzles are not gusseted.
Gauges Ensure gauges are visible, working, no leakage, and suitable for range of MAWP/Temp.	X				No gages on vessel.
External Piping Ensure pipe is well supported. All clamps, supports, shoes, etc. in place. Look for evidence of structural overload, deflection, etc. Paint condition, external corrosion?	X				Well supported, all shoes in place.
Valving Ensure no leaks are visible. Valves are properly supported and chained if necessary.	X				No leaks – chains not required.

PSV Ensure PSV is set at pressure at or below that of vessel. Discharge piping is same size as inlet to valve and is properly supported and routed. Ensure no block valves between psv and vessel or if there are they are locked open.	X				Located on inlet piping – set at MAWP of vessel.
NDE methods Was UT/ MPI done on vessel (MI coordinator to review results)				X	Ultrasonic thickness survey carried out – no metal thickness detected below nominal.
Recommendations or corrective actions : Vessel is Fit for Service or describe corrective actions required) (MIC to review corrective actions with Operations, discuss with Chief Inspector where necessary, and get remedial action implemented)
